# Pre-Purchase inspection

Prepared on behalf of Example Lettings Ltd

123 Preview Street  
Sample City  
London  
AB1 2CD

**May**  
**29th 2024**  
09:00 NZST

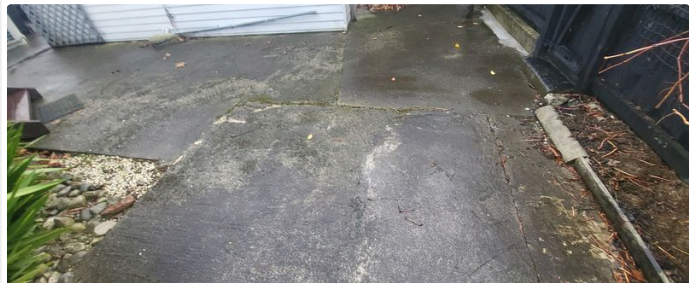
Ref #7 - Driveway Overview, typical cracking

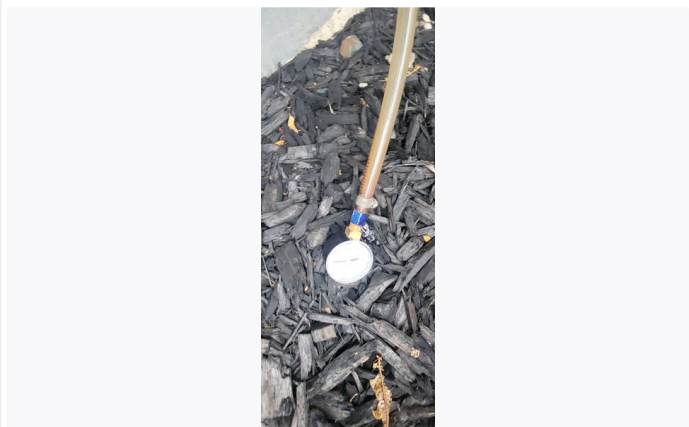
Ref #7 - Water entry pressure Satisfactory 75psi

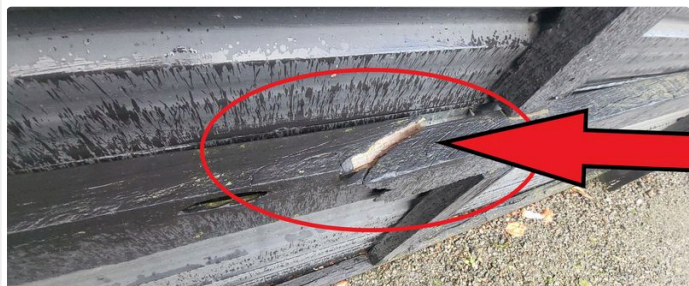
Ref # 7.4 - Timber break in the fence rail

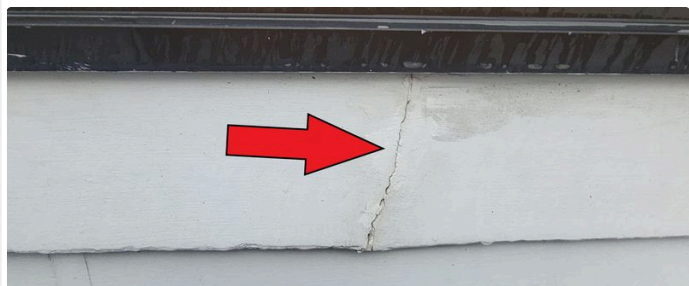
8. EXTERIOR			
Ref	Feature	General condition	Additional Comments
8.1	Cladding Sidding	Satisfactory; a small amount of cracks , some Maintenance Required	Cement weatherboard; Fiberboard Repairs or Maintenance Required
8.2	Windows Type & Exterior Condition	Satisfactory	Aluminum joinery, Double glazing; Retrofitted

Ref # 8.1 - Repair or seal cracks in weatherboard

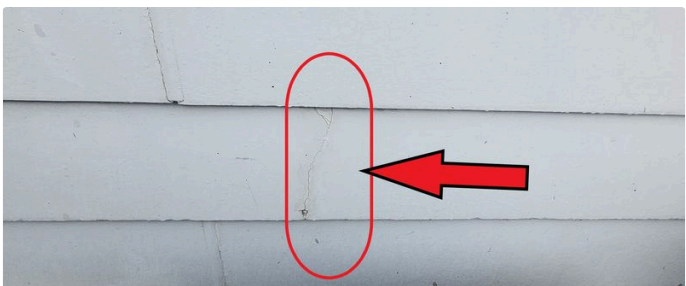
Ref # 8.1 - Repair or seal cracks in weatherboard

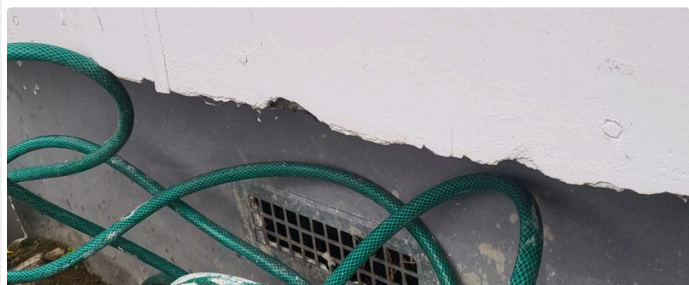
Ref # 8.1 - Chipped weatherboard in places

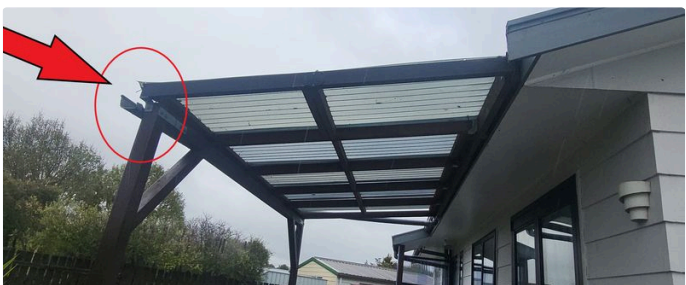
8. EXTERIOR (CONT.)			
8.3	Flashings	Satisfactory	Timber; Painted Steel
8.4	Gutters/Scuppers/ Eavestrough	Satisfactory	PVC/Vinyl Repairs or Maintenance Required
8.5	Downpipes	Satisfactory	PVC/Vinyl
8.6	Eaves, Fascia & Soffits	Satisfactory	
8.7	Trims	Satisfactory	Timber; painted
8.8	Service Entry	Not Visible; Not Inspected	underground; not visible
8.9	Exterior wall Construction	Not Visible; Framed	Framed; not visible
8.10	Fascia	Satisfactory	Timber; Fiberboard
8.11	Caulking	Satisfactory	
8.12	Slab-on-Grade/ Foundation		NA
8.13	Kick/Bace boards	Somp chips and rough in places, overall functions as intended	Timber; Cement Board
8.14	Comments Observations Recommendations	Some painting/sealing needed around the window scribing, and maby just the two cracks in the weathrboard that needs sealing up. the exterior cladding is overall satisfactory

Ref # 8.4 - Some Repairs/Maintenance required

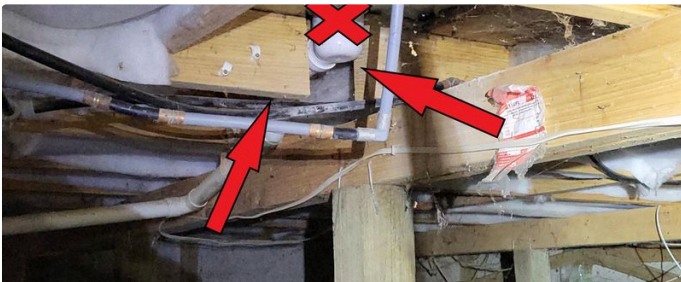
13. CRAWL SPACE (CONT.)		
13.3	Joists/Beams	Timber; Jost has been cut to fit the shower tray, one section is now not supported, This should be supported <b>Repairs or Maintenance Required</b>

Ref # 13.3 - Joist cut out, needs suporting

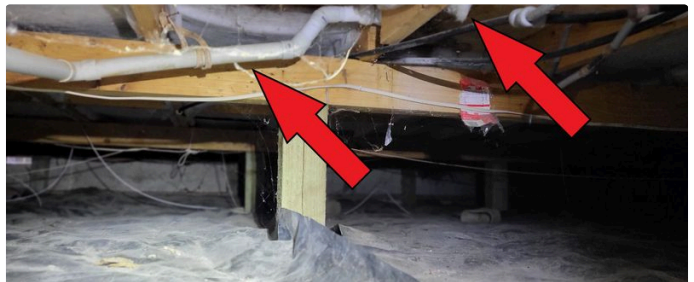
13.14	Underfloor Plumbing issues observed	No S trap installed in the shower, recomend fitting one to stop fowel water/gas from rising back into the shower and home. <b>Repairs or Maintenance Required</b>

Ref # 13.14 - No S trap installed in the shower

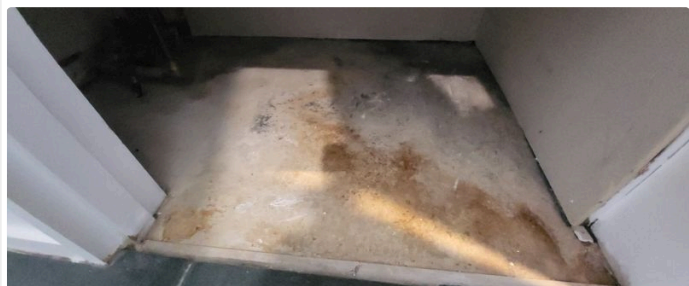
15. HALLS AND PASSAGEWAYS		
Ref	Name	Condition
15.1	Floorings	Carpet (Fitted)
15.2	Walls	Plasterboard; Painted; general marks and wear
15.3	Lights and sockets	A representative number of lights have been checked and functioned satisfactorily at the time of the inspection; A representative number of Switches have been checked and functioned satisfactorily at the time of the inspection
15.4	Windows	A representative number of windows have been checked and functioned satisfactorily at the time of the inspection
15.5	Hot water cupboard	Some historic water staning and minor damage to the chipboard flooring, mostly cosmetic now damage visible under the flooring. <span>Monitor</span>

Ref # 15.5 - historic water staining and minor damage to the chipboard flooring

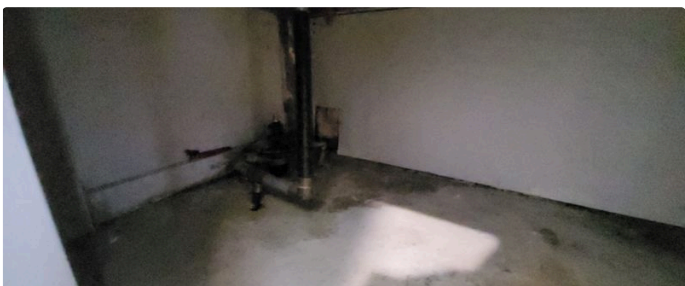
Ref # 15.5 - historic water staining and minor damage to the chipboard flooring

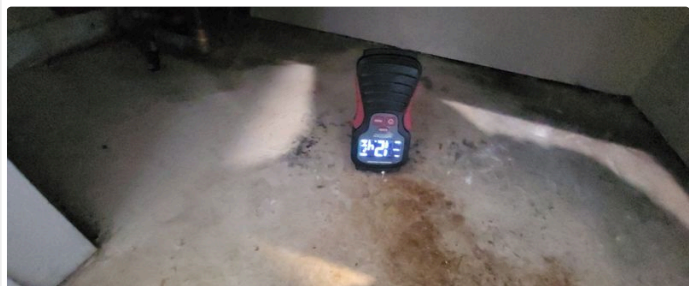
Ref # 15.5 - Tested and No Moisture was recorded at the time of the inspection

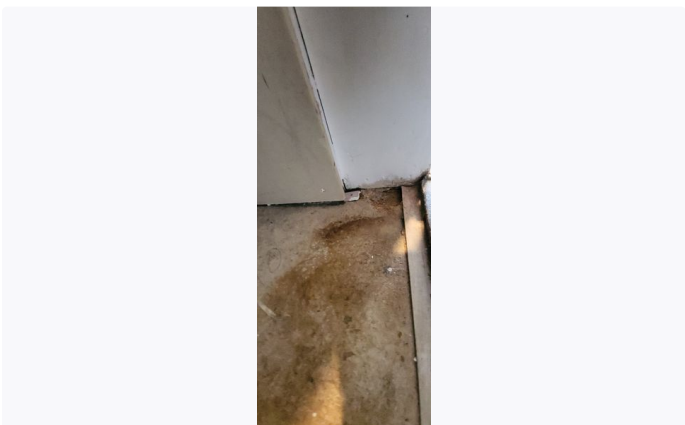
Ref # 15.5 - historic water staining and minor damage to the chipboard flooring

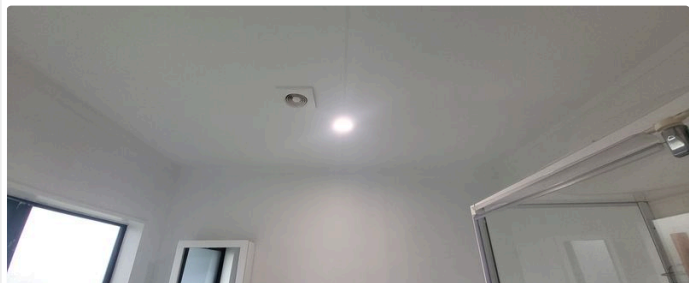
Ref #18 - Ceiling fan tested satisfactory

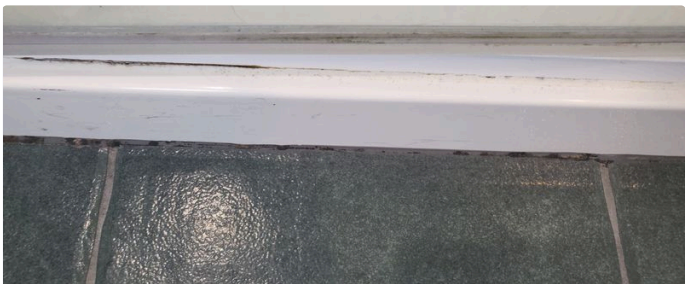
18. MAIN/HALL BATHROOM INCLUDING TOILET/WATER CLOSET		
Ref	Feature	Description
18.1	Bath	No leaks and drains flow freely at the time of the inspection
18.2	Toilet	operated at the time of the inspection
18.3	Shower	No leaks and drains flow freely at the time of the inspection; sealer is old and a bit fragile and moldy , concider removing old sealer and resealing,

18. MAIN/HALL BATHROOM INCLUDING TOILET/WATER CLOSET (CONT.)		
18.4	Vanity	Satisfactory general ware observed
18.5	Floor or floor coverings	Fitted Tiles; some loose grouting around the shower.; Satisfactory at the time of inspection; general wear
18.6	Walls and Ceiling	Painted wall panels; tiles; sealing required
18.7	Extractor	Observed operating at the time of the inspection
18.8	Heating	NA
18.9	Moisture Levels	Moisture readings were taken from key points around the room and windows and all reading were satisfactory at the time of inspection
18.10	Comments Observations

Ref #18 - moldy silicone , loose grout

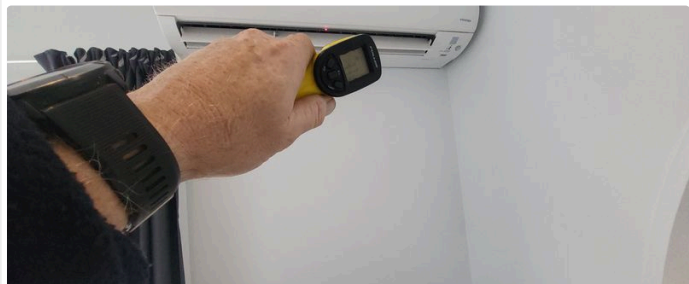
Ref #27 - Heat pump tested satisfactory under heavy load and normal operation

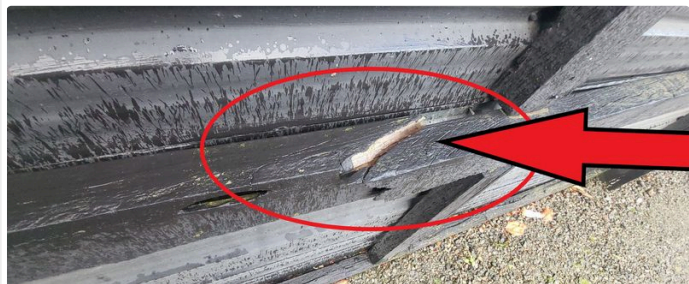
<p>Ref # 7.4 - Timber break in the fence rail</p></div>			
8.1 Exterior » Cladding Sidding	Repairs or Maintenance Required	N/A	Repair or seal cracks in weatherboard
<div><div>

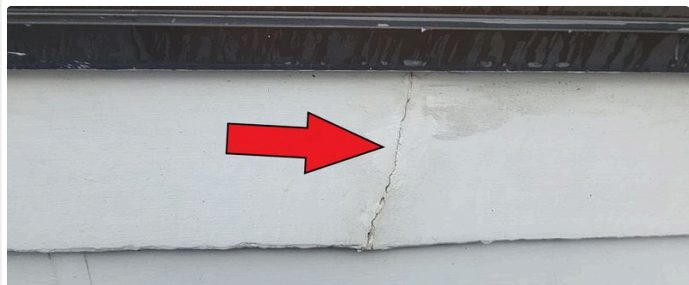
<p>Ref # 8.1 - Repair or seal cracks in weatherboard</p></div><div>

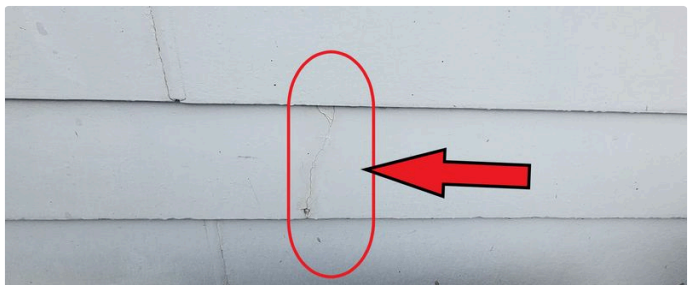
<p>Ref # 8.1 - Repair or seal cracks in weatherboard</p></div></div>			
<div>

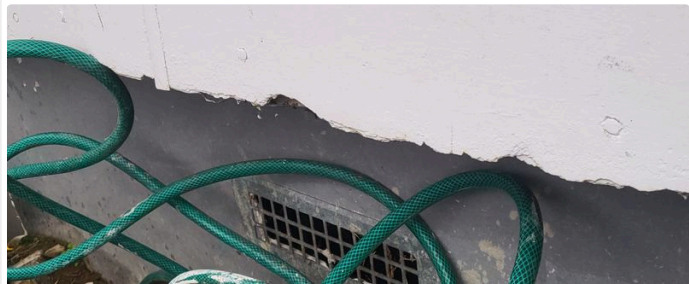
<p>Ref # 8.1 - Chipped weatherboard in places</p></div>			
8.4 Exterior » Gutters/Scuppers/ Eavestrough	Repairs or Maintenance Required	N/A	Some Repairs/Maintenance required

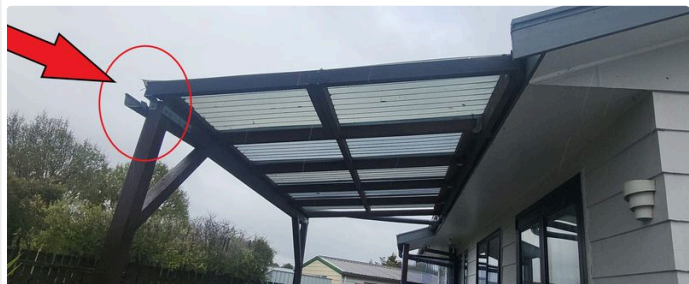
<p>Ref # 8.4 - Some Repairs/Maintenance required</p></div>			
<a href="#">13.3</a> Crawl Space » Joists/Beams	Repairs or Maintenance Required	N/A	Joist has been cut to fit the shower tray, one section is now not supported, This should be supported;
<div>

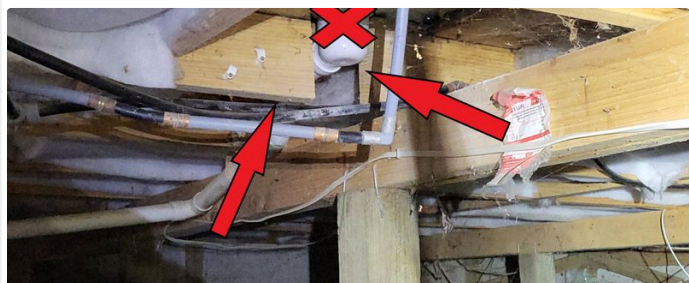
<p>Ref # 13.3 - Joist cut out, needs suporting</p></div>			
<a href="#">13.13</a> Crawl Space » Visible Plumbing.	Monitor	N/A	Dux Quest plumbing is now over 35 years old and past the manufacturer's expected lifetime
<a href="#">13.14</a> Crawl Space » Underfloor Plumbing issues observed	Repairs or Maintenance Required	N/A	No S trap installed in the shower, recomend fitting one to stop fowel water/gas from rising back into the shower and home.;
<div>

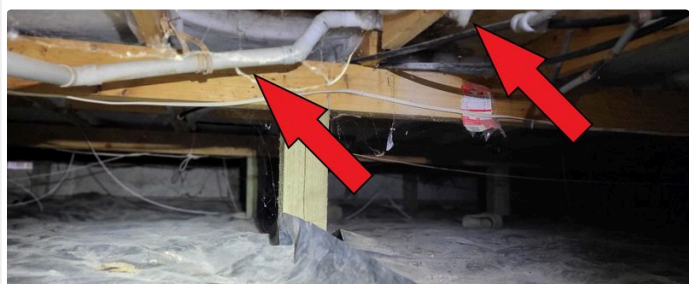
<p>Ref # 13.14 - No S trap installed in the shower</p></div>

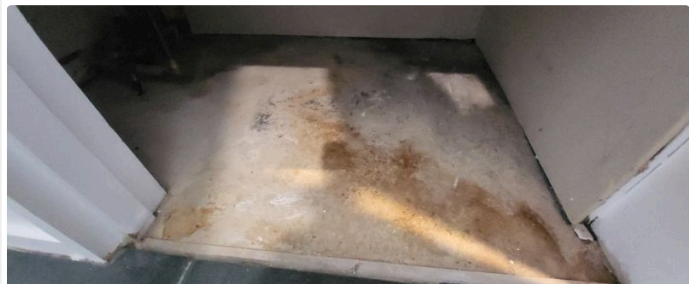
Actions Required			
<a href="#">15.5</a> Halls and passageways » Hot water cupboard	Monitor	N/A	Some historic water staining and minor damage to the chipboard flooring, mostly cosmetic now damage visible under the flooring.

<p>Ref # 15.5 - historic water staining and minor damage to the chipboard flooring</p>

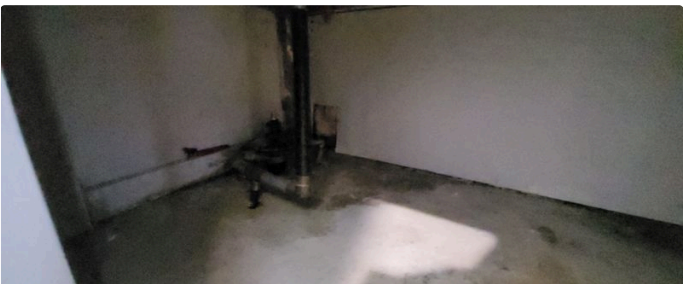
<p>Ref # 15.5 - historic water staining and minor damage to the chipboard flooring</p>

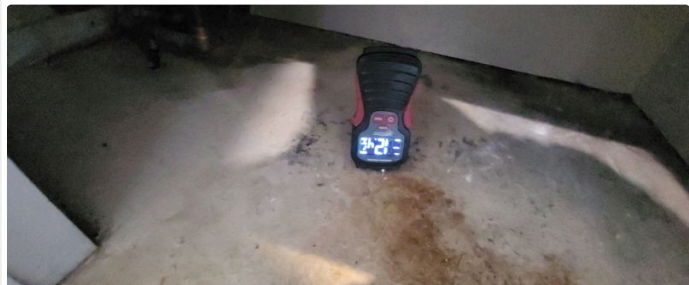
<p>Ref # 15.5 - Tested and No Moisture was recorded at the time of the inspection</p>
