Pre-Purchase inspection

Prepared on behalf of Example Lettings Ltd

123 Preview Street
Sample City
London
AB1 2CD

June
3rd 2025
09:00 NZST

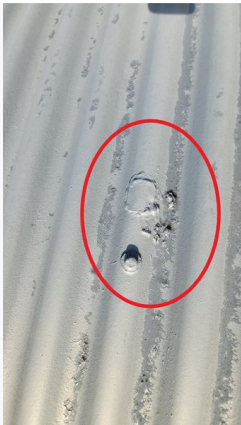
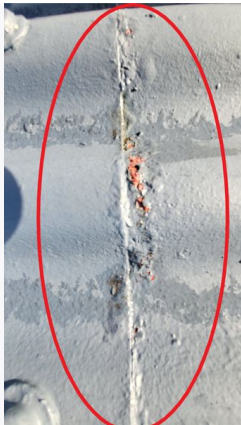
10.3	Roof General Condition	Marginal	some oxidation or rust visible in the laps, some historic repairs visible Investagation required
10.4	Plumbing Vents	Satisfactory

Ref #10.3 - Some oxidation or rust is visible in the laps joins, and some historic repa

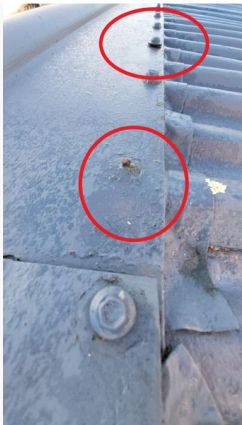
10.5	Fixings	Marginal	Some loose or missing lead heads ; Even though the remaining lead head nails look satisfactory now, we can't guarantee there isn't any existing damage. Over time, these nails tend to loosen, allowing water to collect underneath. This trapped water can then lead to oxidation, corrosion, and rust, which silently degrade the roofing iron. Eventually, this can cause water to leak through, potentially resulting in water damage or wood rot. It's important to know that lead head nails were discontinued in the 1980s precisely because of these inherent problems. Repairs or Maintenance Required

Ref #10.5 - Some loose or missing lead heads

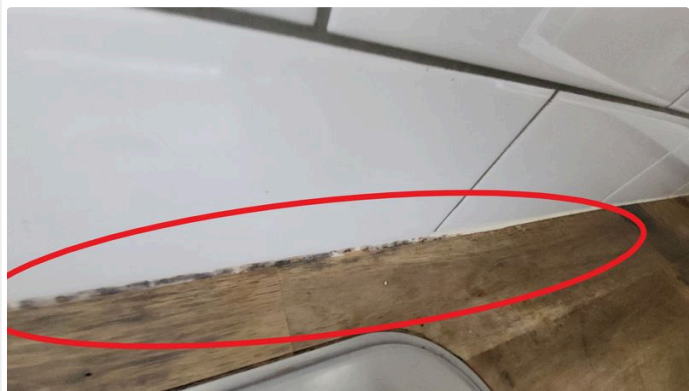
17. KITCHEN			
Ref	Feature	General Condition	Additional Comments
17.1	Bench Top	Satisfactory	General wear and tear; Areas of mould growing in the silicone sealer, consider re-sealing for health and hygiene Safety Hazard, Action Required

Ref #17.1 - Areas of mould growing in the silicone sealer, consider re-sealing for heal

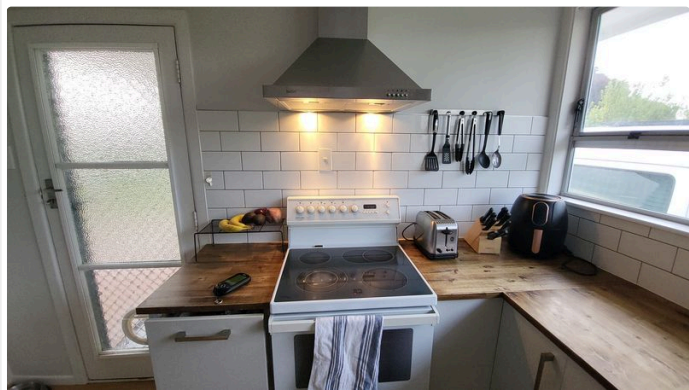
17.6	Hob		Electric; Observed Functioning at the time of the inspection
17.7	Dishwasher		Observed functioning at the time of the inspection
17.8	Extractor		Operated; needs filters cleaned

Ref #17.8 - Operated; needs filters cleaned;

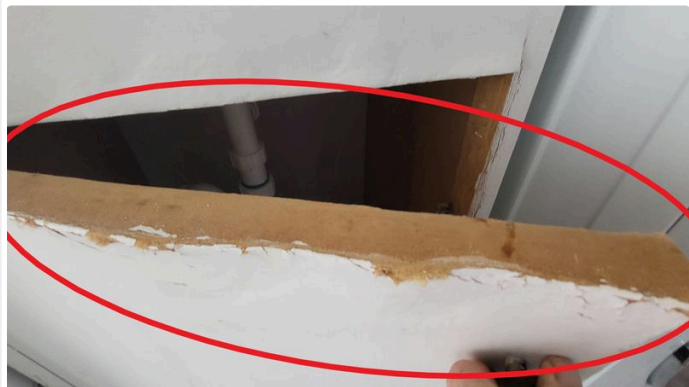
Ref #22.6 - puffy MDF, water damage

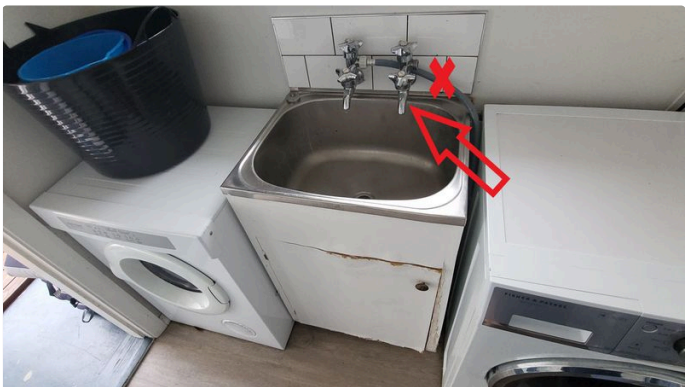
Ref #22.6 - loose tapware, no hot water from the faucet

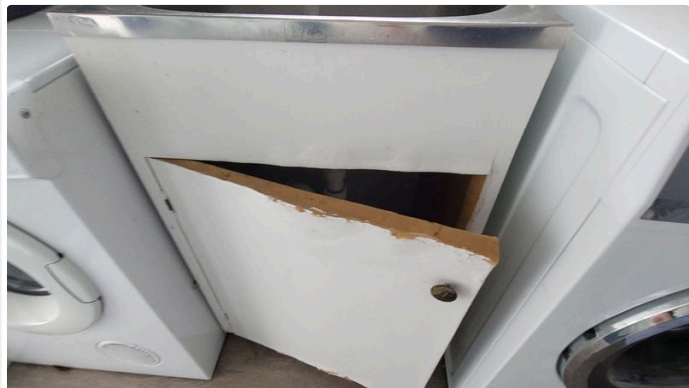
Ref #22.6 - cabnet is in overall poor condition

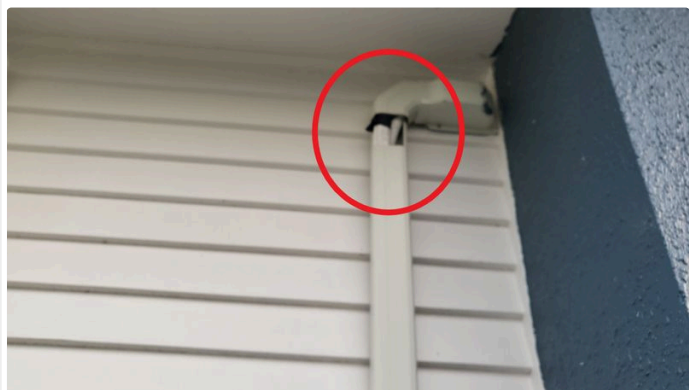
Ref #26.4 - ducting has come loose, minor maintained required;

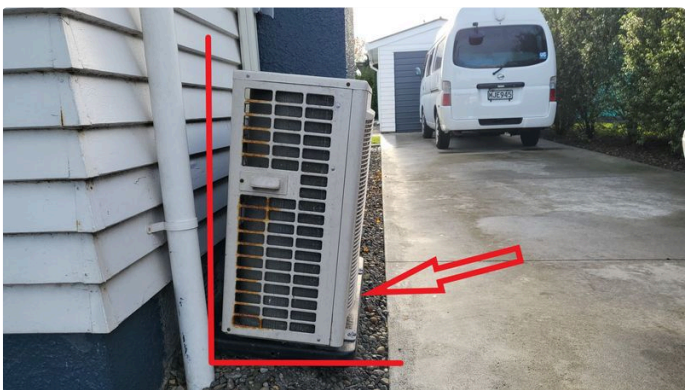
Ref #26.5 - Out door unit not secure, requires better foundation and needs leveling

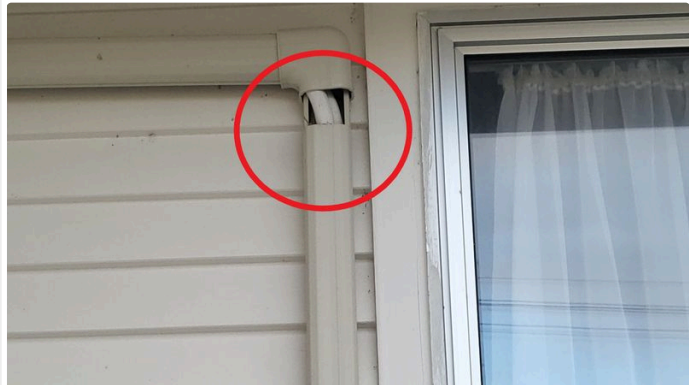
Ref #28.4 - ducting has come loose, minor maintained required;

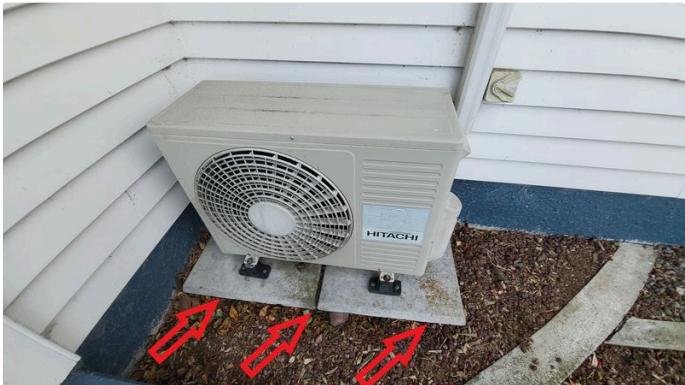
Ref #28.5 - not secure, requires better foundation

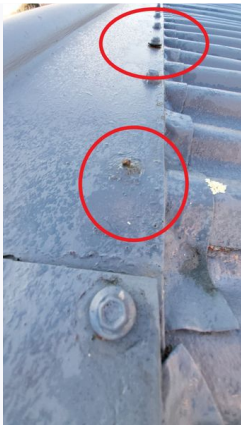
10.5 Roof continued » Fixings	Repairs or Maintenance Required	N/A	Some loose or missing lead heads
<div>

<p>Ref #10.5 - Some loose or missing lead heads</p> </div>

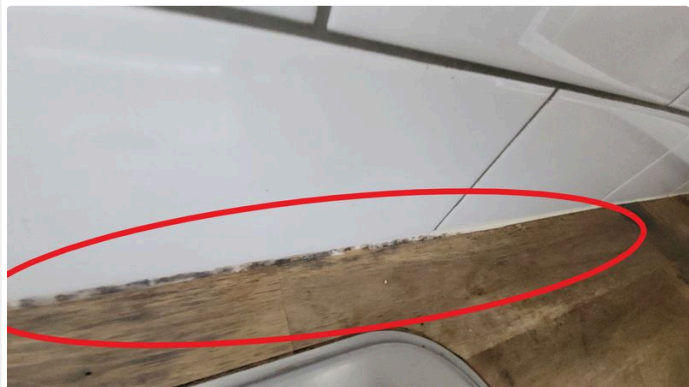
17.1 Kitchen » Bench Top	Safety Hazard, Action Required	N/A	Aeras of mould growing in the silicone sealer, consider re-sealing for health and hygiene

<p>Ref #17.1 - Aeras of mould growing in the silicone sealer, consider re-sealing for heal</p> </div>			
<div> <p>22.6 Laundry » Laundry Tub, taps and cabnets</p> </div>	<div> <p>Repairs or Maintenance Required</p> </div>	<div> <p>N/A</p> </div>	<div> <p>loose tapware, no hot water from the faucet, cabinet is in poor condition</p> </div>
<div>

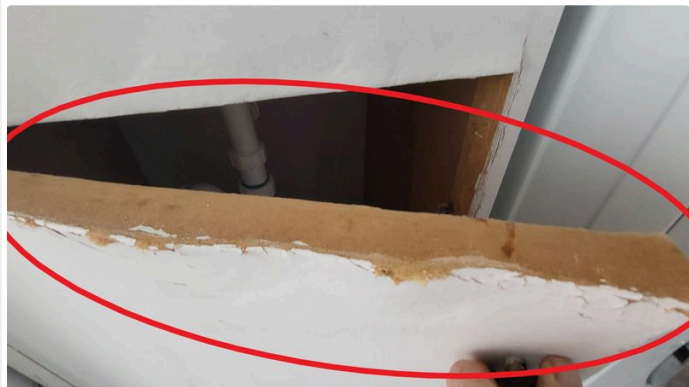
<p>Ref #22.6 - puffy MDF, water damage</p> </div> <div>

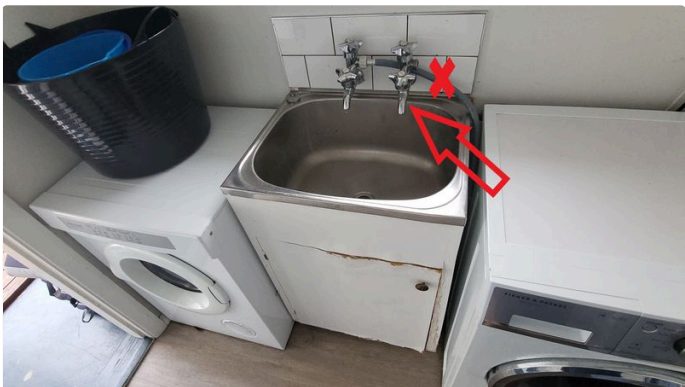
<p>Ref #22.6 - loose tapware, no hot water from the faucet</p> </div>			
<div>

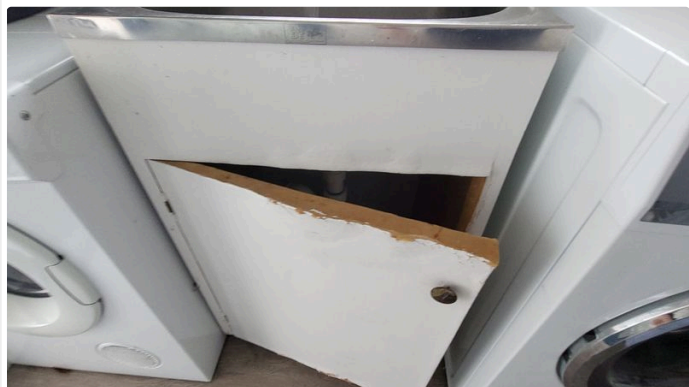
<p>Ref #22.6 - cabnet is in overall poor condition</p> </div>			
<div> <p>26.4 Heat Pump 1 Continued » Ducting/ trunking</p> </div>	<div> <p>Repairs or Maintenance Required</p> </div>	<div> <p>N/A</p> </div>	<div> <p>ducting has come loose, minor maintained required;</p> </div>

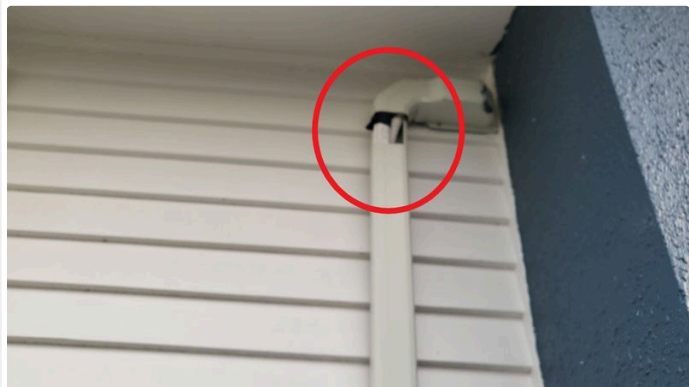
<p>Ref #26.4 - ducting has come loose, minor maintained required;</p> </div>			
<div> <p>26.5 Heat Pump 1 Continued » Level</p> </div>	<div> <p>Repairs or Maintenance Required</p> </div>	<div> <p>N/A</p> </div>	<div> <p>Out door unit not secure, requires better foundation and needs leveling</p> </div>
<div>

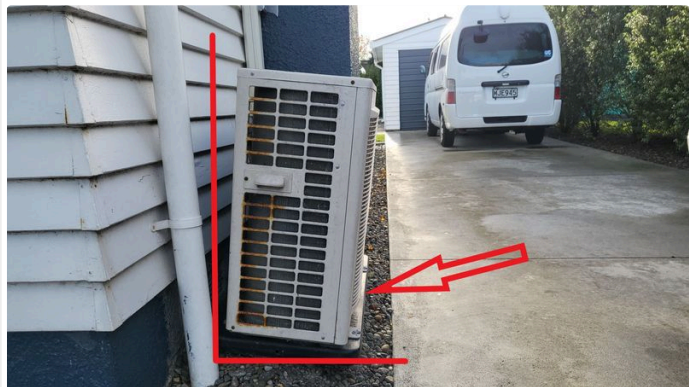
<p>Ref #26.5 - Out door unit not secure, requires better foundation and needs leveling</p> </div>			
<div> <p>28.4 Heat Pump 2 Continued » Ducting/ trunking</p> </div>	<div> <p>Repairs or Maintenance Required</p> </div>	<div> <p>N/A</p> </div>	<div> <p>ducting has come loose, minor maintained required;</p> </div>
<div>

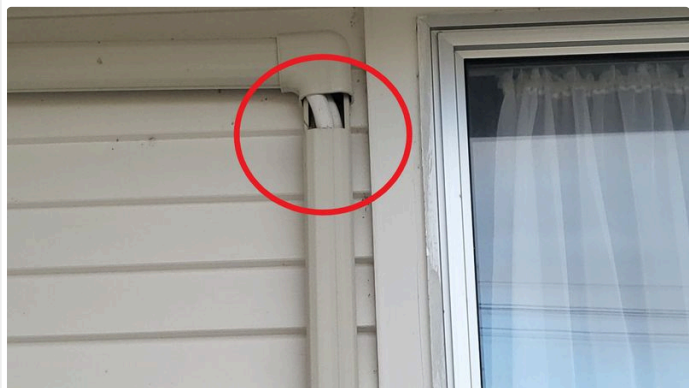
<p>Ref #28.4 - ducting has come loose, minor maintained required;</p> </div>			
<div> <p>28.5 Heat Pump 2 Continued » Level</p> </div>	<div> <p>Repairs or Maintenance Required</p> </div>	<div> <p>N/A</p> </div>	<div> <p>not secure, requires better foundation</p> </div>

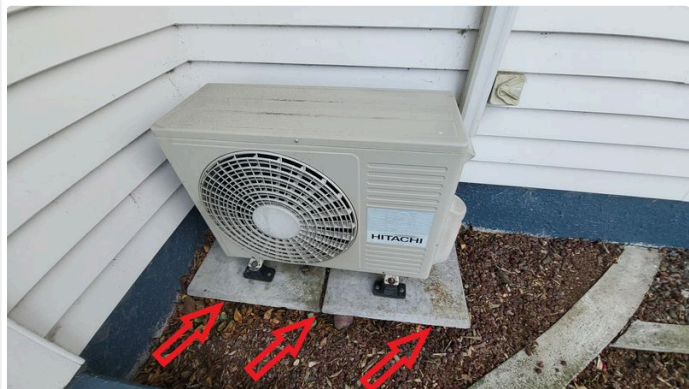
Ref #28.5 - not secure, requires better foundation
