Pre-Purchase inspection

Prepared on behalf of Example Lettings Ltd

123 Preview Street
Sample City
London
AB1 2CD

June
3rd 2025
09:00 NZST

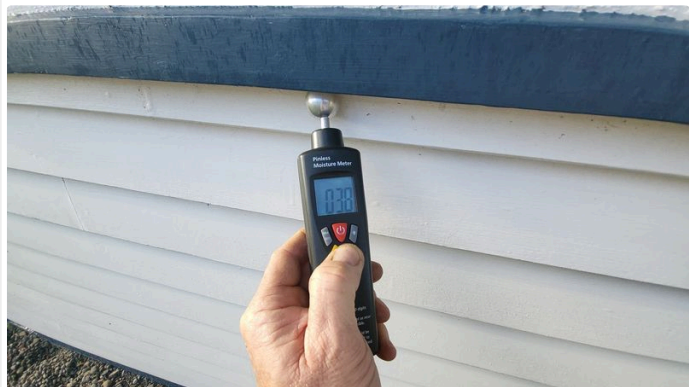
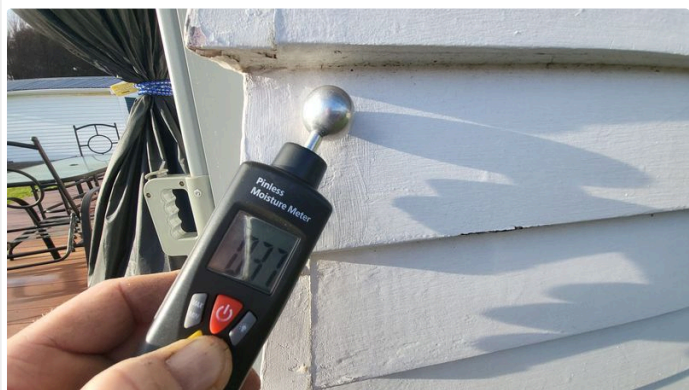
Ref #8.2 - Exterior Moisture Testing reference and example photos;

8.2	Exterior Moisture Testing	Exterior Moisture Testing readings were satisfactory at the time of the inspection	
8.3	Windows Type & Exterior Condition	Satisfactory at the time of inspection	Aluminum inserts with retro fitted double glazing. overall satisfactory , typical rubberwear shrinkage in some windows. Monitor
