# Pre-Purchase inspection

Prepared on behalf of Example Lettings Ltd

123 Preview Street  
Sample City  
London  
AB1 2CD

**May**  
**29th 2024**  
09:00 NZST

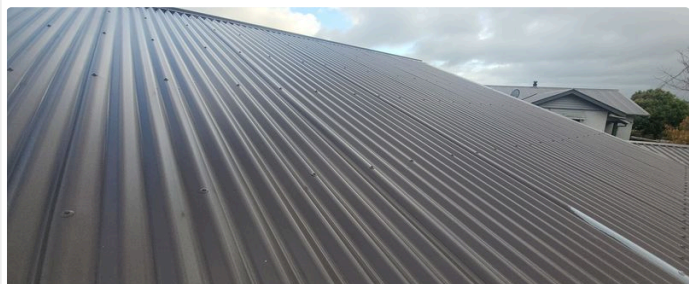
Ref #9 - Satisfactory at the time of the inspection, Roof overview #3;

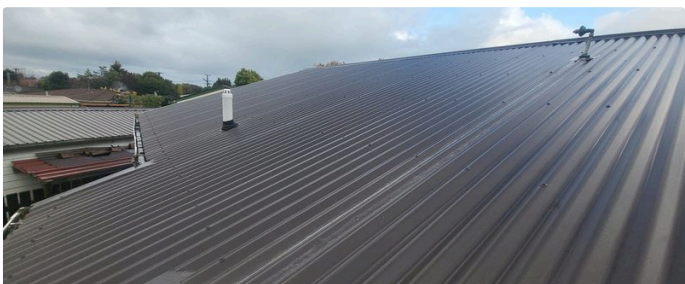
Ref #9 - Satisfactory at the time of the inspection, Roof overview #1

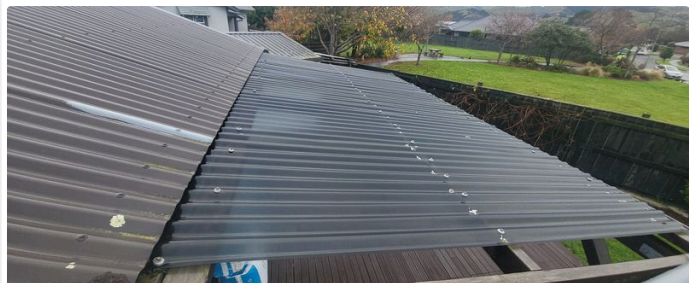
Ref #9 - Satisfactory at the time of the inspection, Roof overview #9

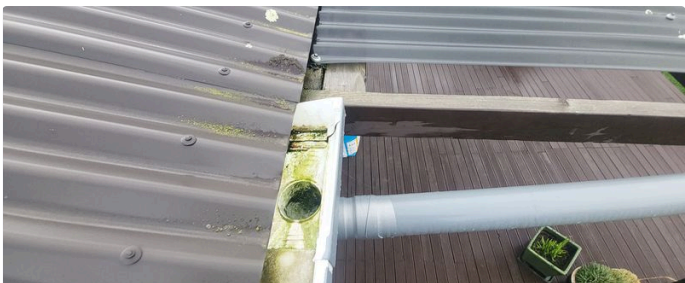
Ref #9 - Satisfactory at the time of the inspection, Roof overview #4

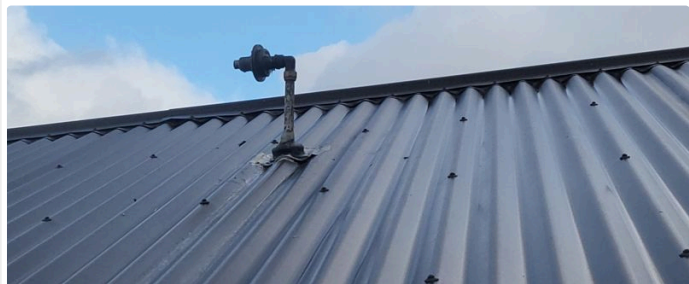
Ref #9 - Satisfactory at the time of the inspection, Roof overview #8;

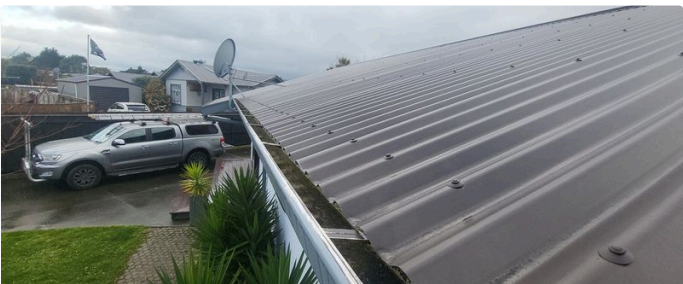
Ref #9 - Satisfactory at the time of the inspection, Roof overview #10

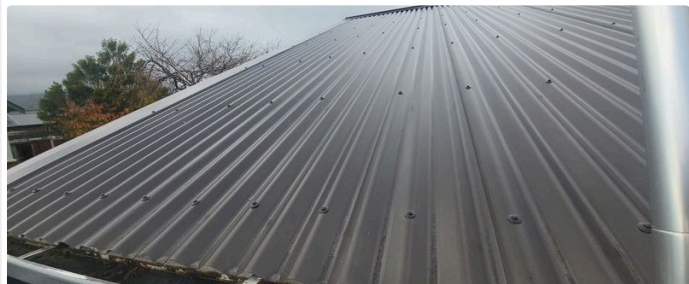
Ref #9 - Satisfactory at the time of the inspection, Roof overview #11

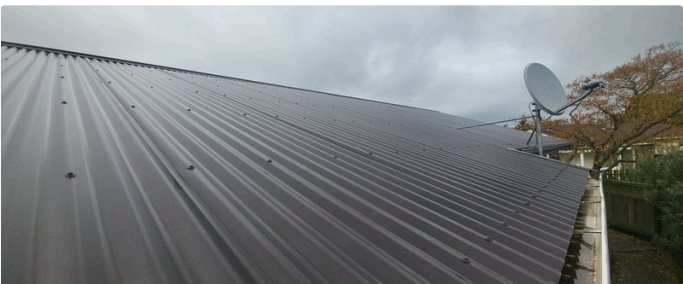
Ref #9 - Satisfactory at the time of the inspection, Roof overview #17

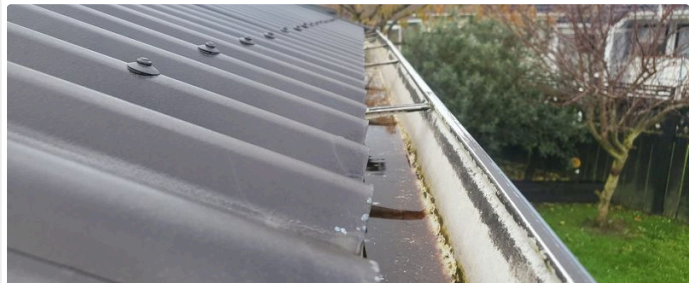
Ref #9 - Satisfactory at the time of the inspection, Roof overview #14

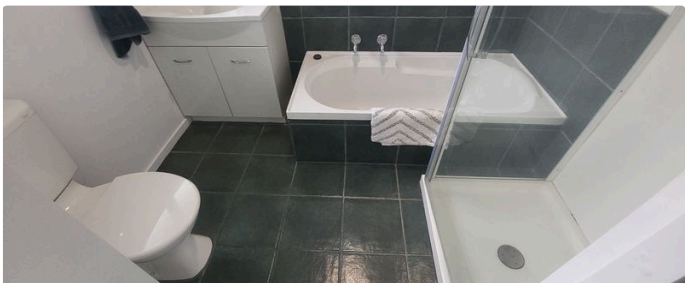
Ref #18 - Overview

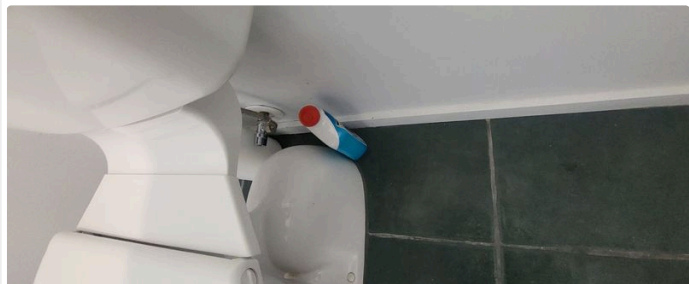
Ref #18 - No Plumbing issues visible

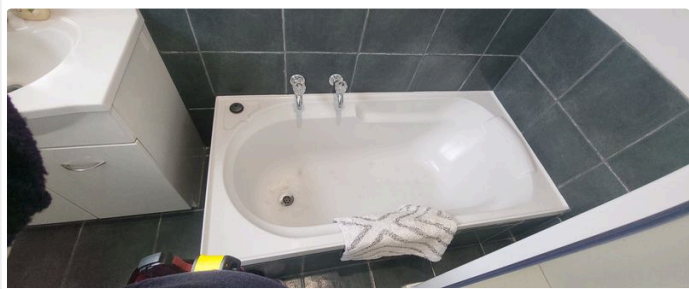
Ref #18 - overview

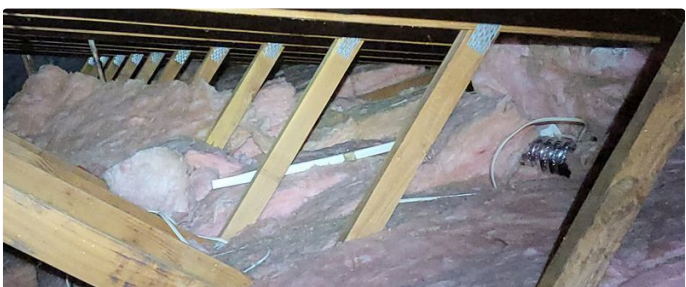
Ref #25 - Insulation , Ceiling and Structure Overview #2

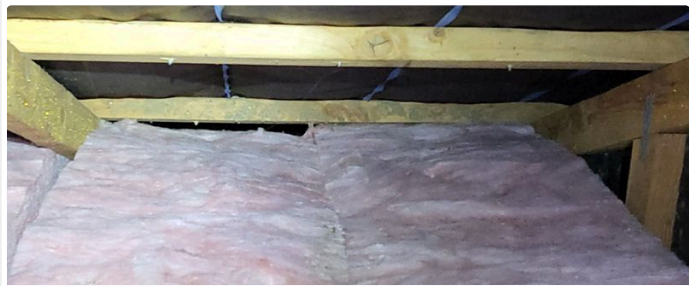
Ref #25 - Insulation , Ceiling and Structure Overview #8

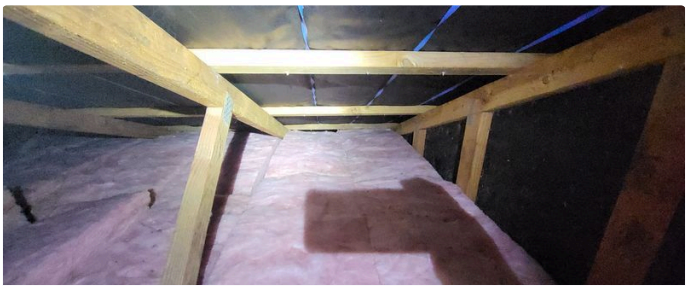
Ref #25 - Insulation , Ceiling and Structure Overview#11

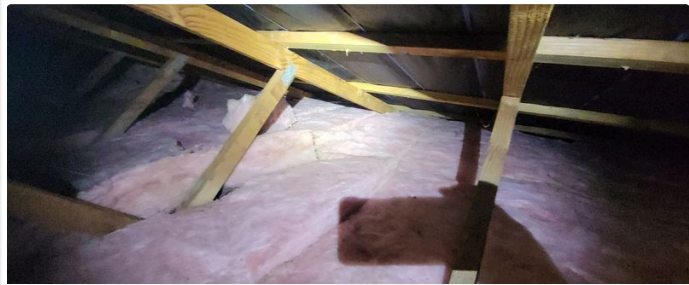
Ref #25 - Insulation , Ceiling and Structure Overview #5

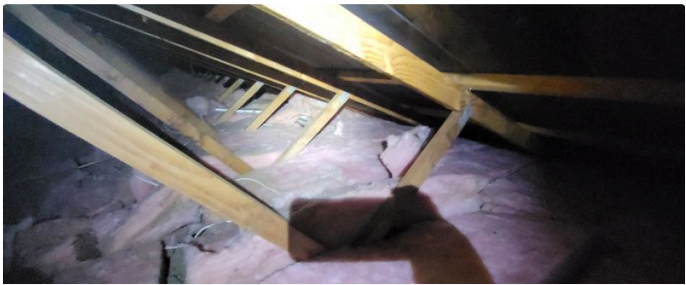
Ref #25 - Insulation, Ceiling and Structure Overview #7

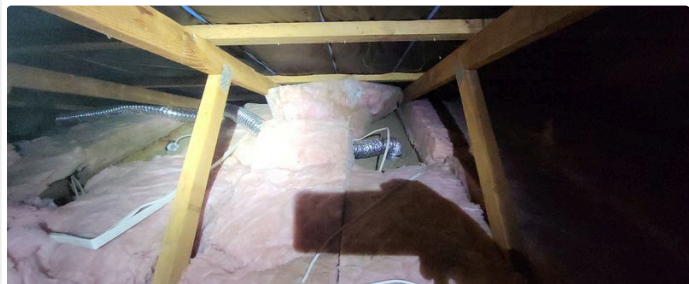
Ref #25 - Insulation , Ceiling and Structure Overview #3

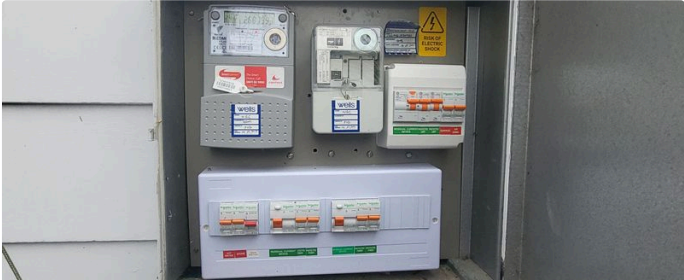
<p>Ref #29 - Modern newly installed main board inc RCDs and breakers, smart meter instal</p></div> <div>

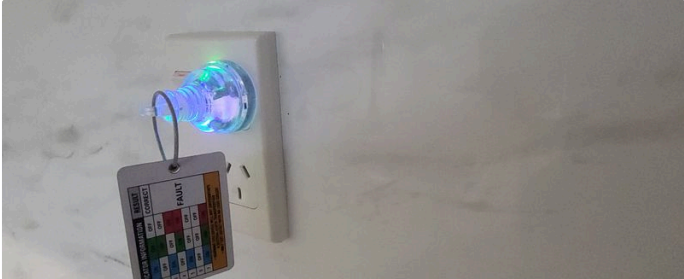
<p>Ref #29 - all socket outlets tested including earth and polarity</p></div>
