Pre-Purchase inspection

Prepared on behalf of Example Lettings Ltd

123 Preview Street
Sample City
London
AB1 2CD

June
3rd 2025
09:00 NZST

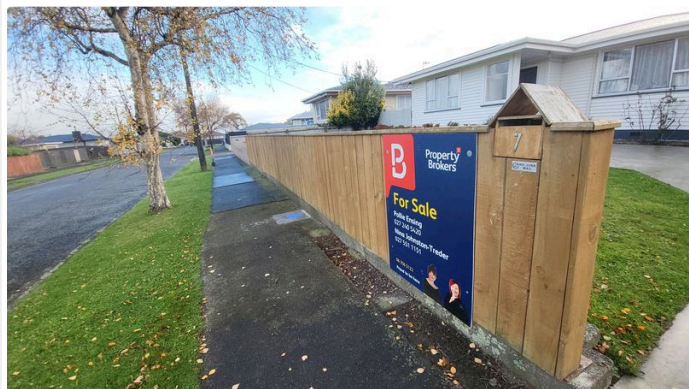
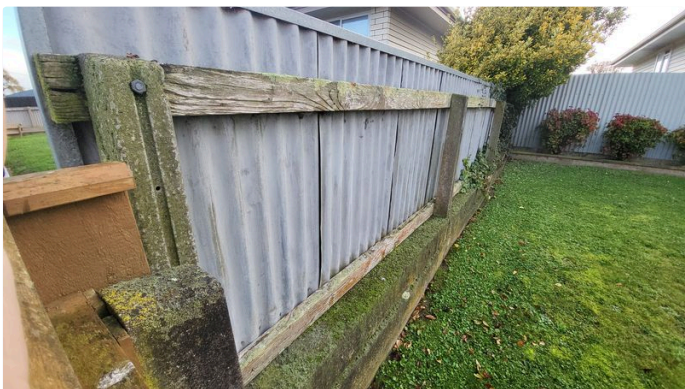
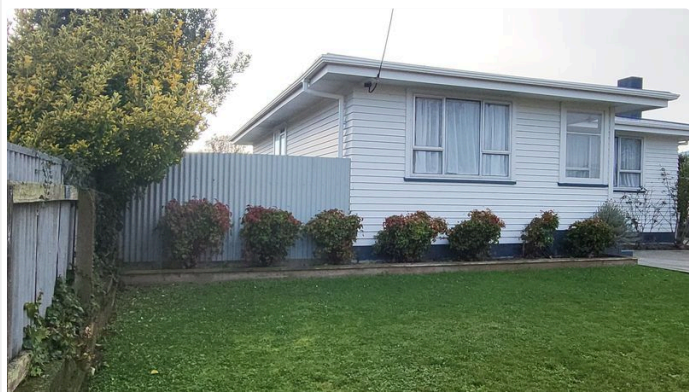
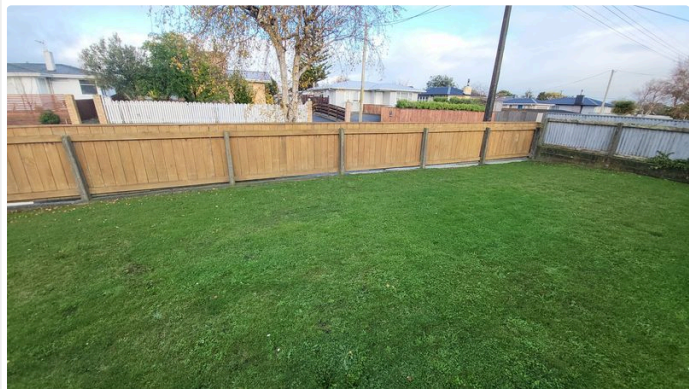
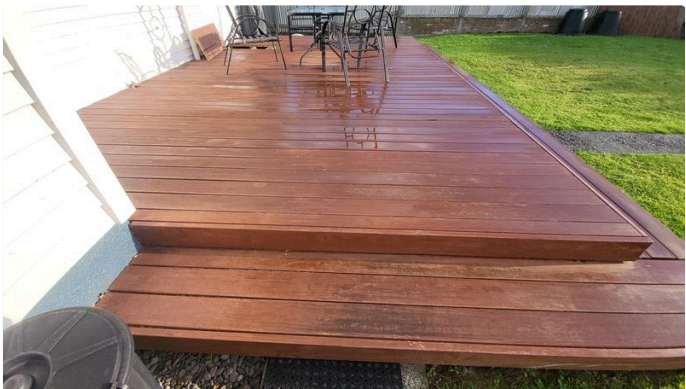
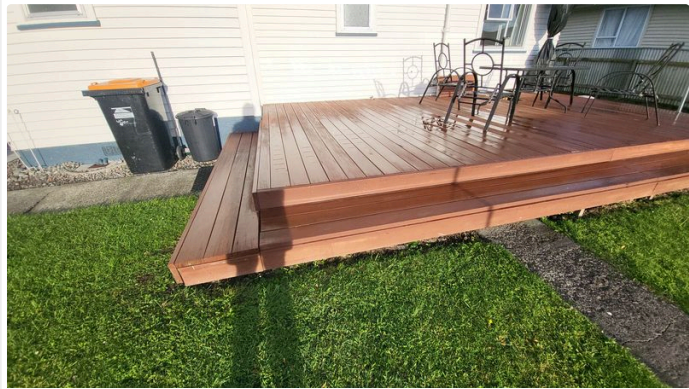
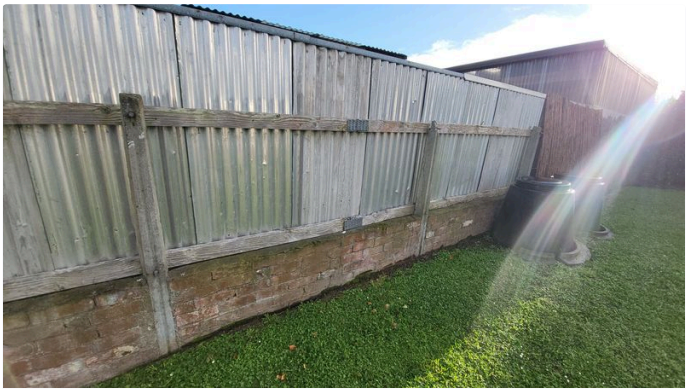
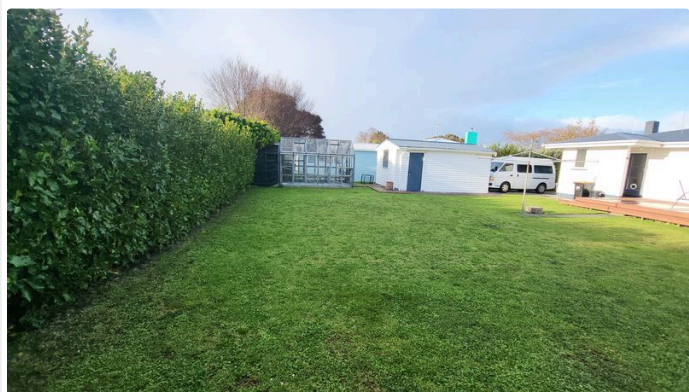
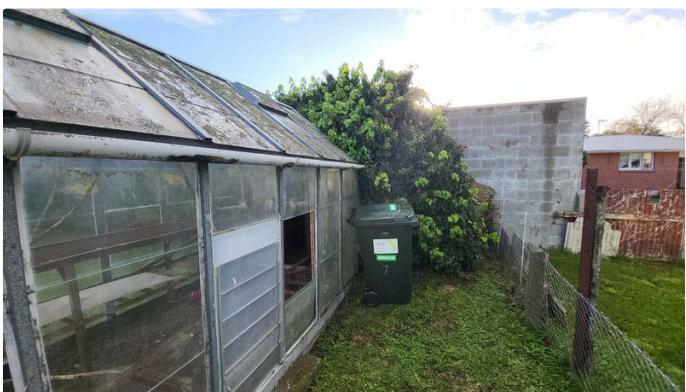
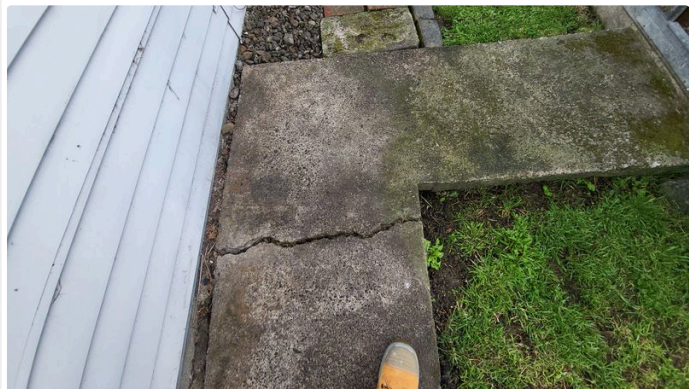
Ref #7 - Site Grounds Reference and example photos;

7. SITE GROUNDS			
Ref	Feature	General Condition	Additional Comments
7.1	Retaining Walls		N/A
7.2	Gardens description	Satisfactory	Well established lawns and gardens
7.3	Paths service walks	Satisfactory	Concrete Typical cacks
7.4	Fences	Satisfactory	Many different materials use, mostly satisfactory and functions as intended; some maintenance may be required.
7.5	Patio		
7.6	Gates		Operated Satisfactory at the time of inspection
7.7	Deck/Balcony	Satisfactory	
7.8	Hose Bibs	Satisfactory	Water Entry and Hose Bib Taps have been checked and working and pressure at the tap was > 68 PSI at the time of inspection
7.9	Driveway and Parking	Satisfactory	newly pored concrete, appears satisfactory , no road to drive run up installed.
7.10	Comments Observations

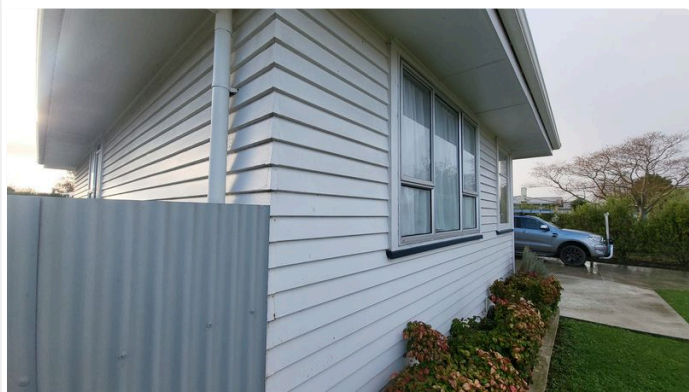
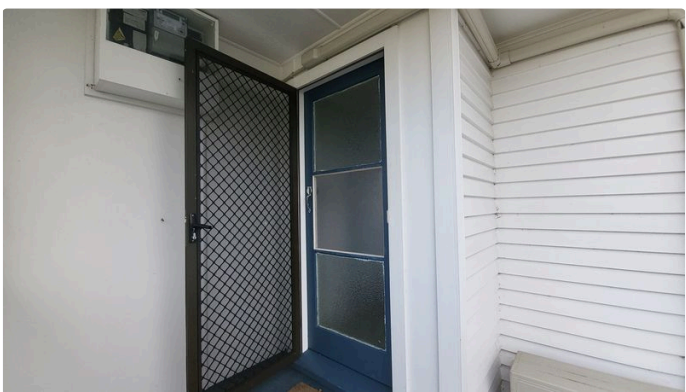
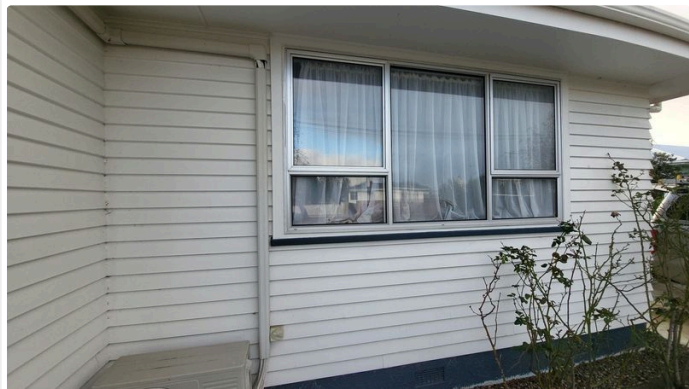
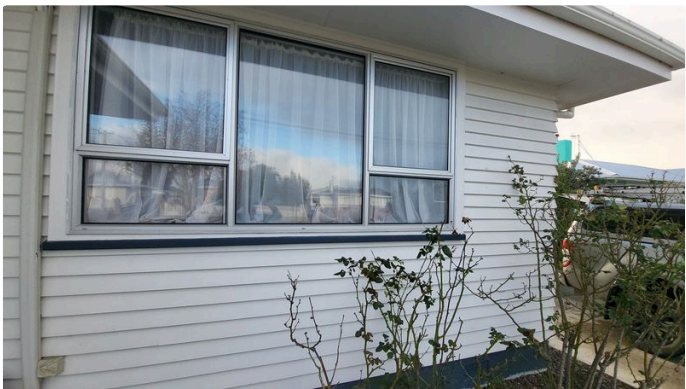
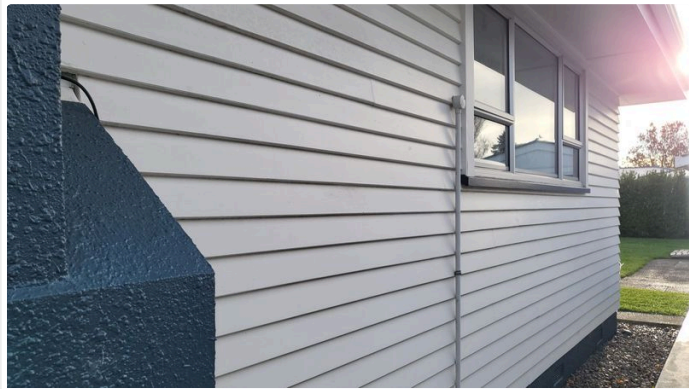
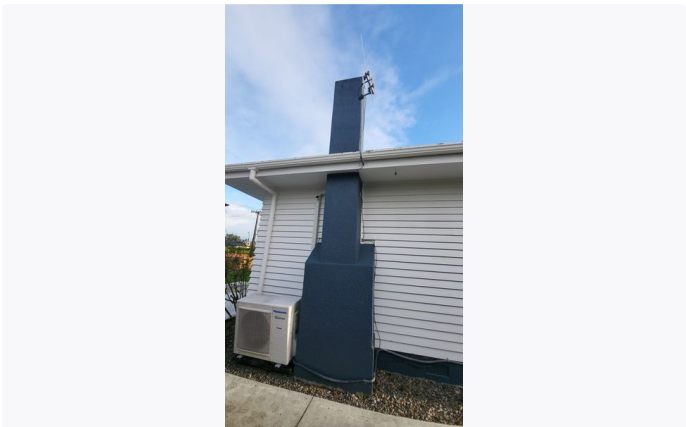
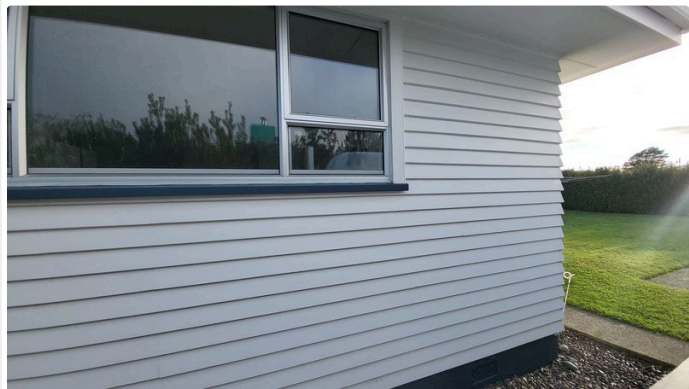
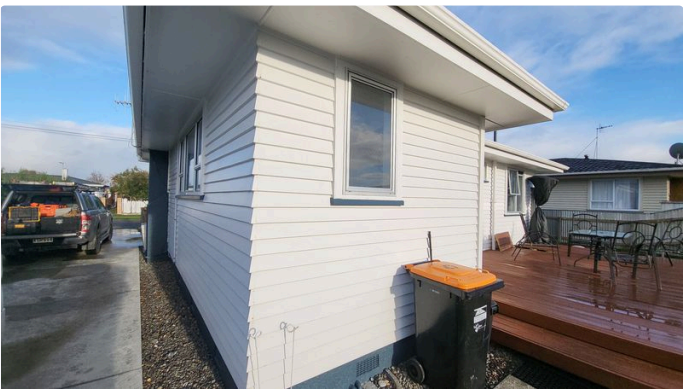
Ref #8 - Exterior Reference and example photos;

8. EXTERIOR			
Ref	Feature	General condition	Additional Comments
8.1	Cladding Sidding	Satisfactory at the time of inspection	(Refer to executive summary for more); Timber cladding with painted finish.; No areas of wood rot observed, Painting and sealing is not perfect, some areas of paint blistering, however given its age etc it is in mostly satisfactory condition. Monitor

8.2	Exterior Moisture Testing	Exterior Moisture Testing readings were satisfactory at the time of the inspection	
8.3	Windows Type & Exterior Condition	Satisfactory at the time of inspection	Aluminum inserts with retro fitted double glazing. overall satisfactory , typical rubberwear shrinkage in some windows. Monitor

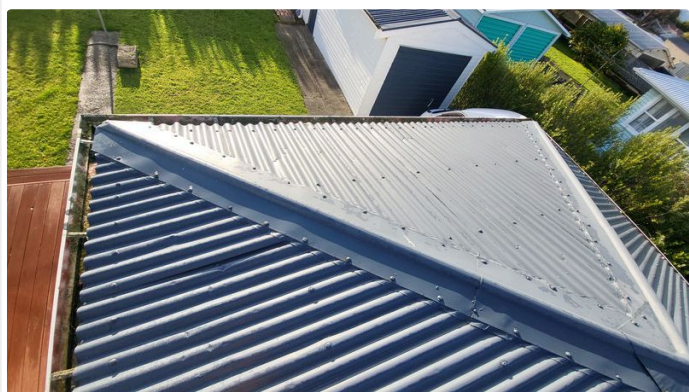
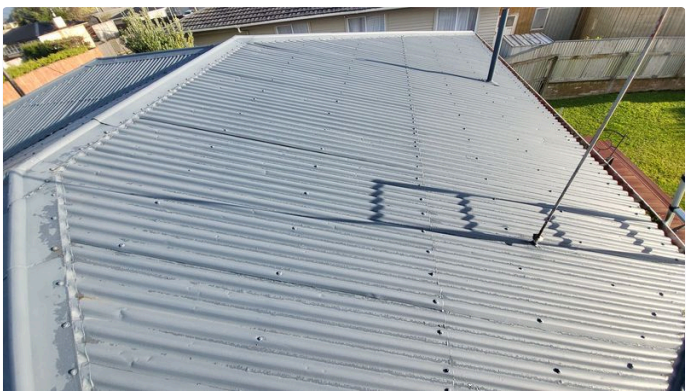
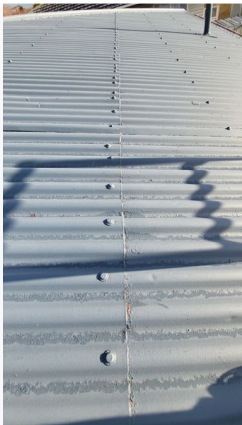
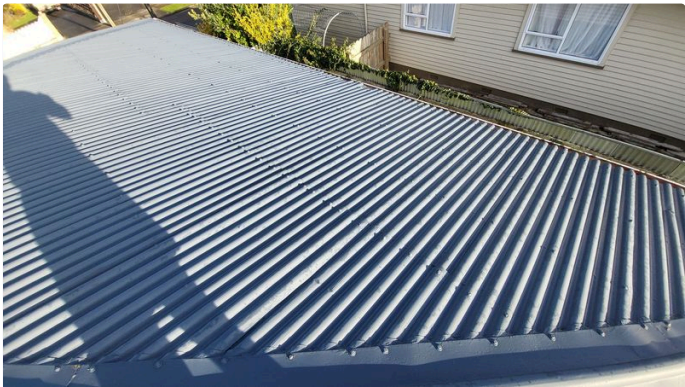
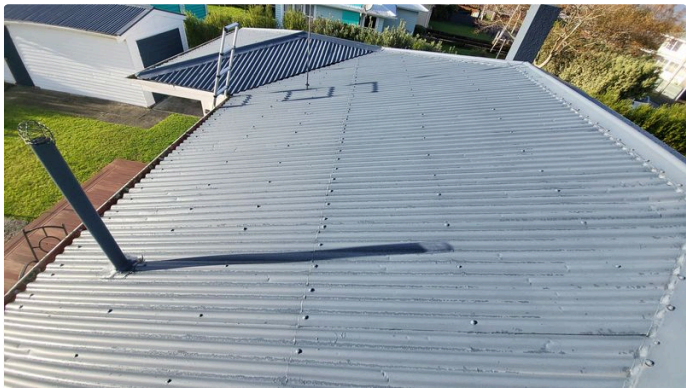
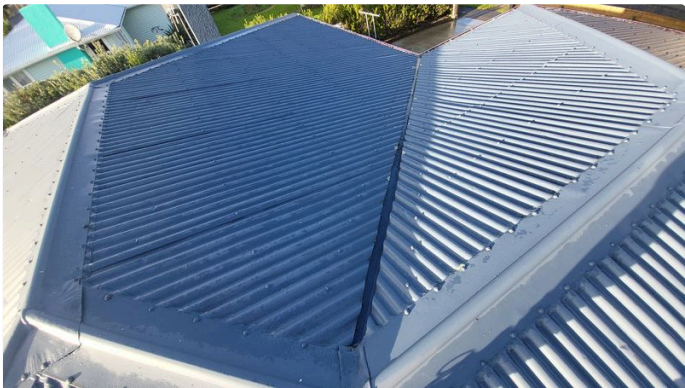
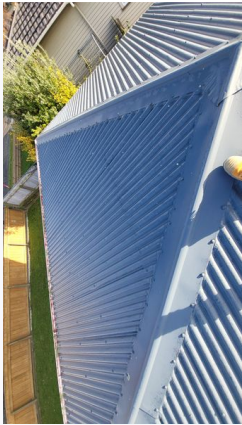
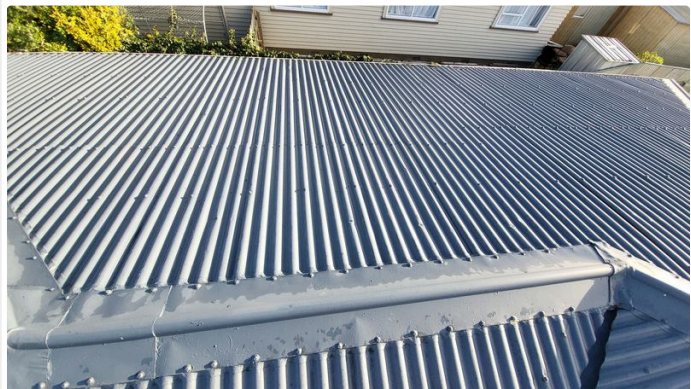
Ref #9 - Roof Exterior Reference and example photos;

9. ROOF EXTERIOR		
Ref	Feature	Description
9.1	Roof Visibility	Representative area
9.2	Approximated Age	Same age as the home
9.3	Inspected from	Walking the roof in safe areas only
9.4	Pitch	>22
9.5	Roof Material	Corrugated iron; painted/powder coated finish
9.6	Fixings used	Nails (lead Head)
9.7	Skylights	
9.8	Ventilation	Satisfactory at the time of inspection; soffit; ridge; roof
9.9	Flashing	formed iron, zinc or galv , painted or powder coated finish
9.10	Comments Observations Recommendations

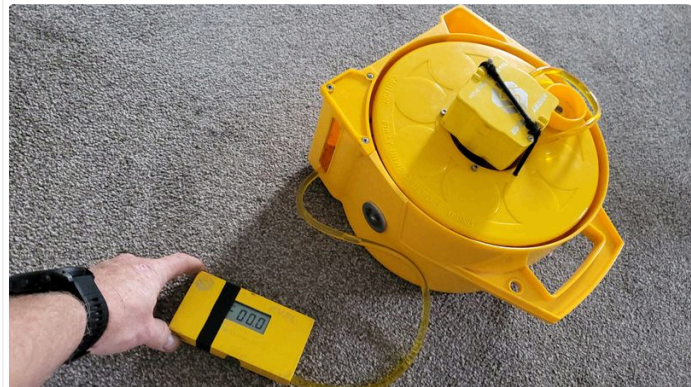
12. FOUNDATION AND FLOORS		
Ref	Feature	Description
12.1	Foundation Type and condition	raised concrete piles,
12.2	Floor Type	timber flooring
12.3	Floor Levels	Floor levels have been taken across the house using a digital smart level and Laser survey completed while there were variants across the floor all levels were within standard tolerances and satisfactory at the time of inspection
12.4	Foundation walls	Concrete ring foundation, (also refer to inspection restrictions).; overall appears satisfactory no cracks of visible areas of concern
12.5	Evidence of Borer or wood mites	None Visible in the accessible and inspectable areas at the time of the inspection
12.6	Comments Observations

Ref #12.3 - Floor level calibration reference photos,;

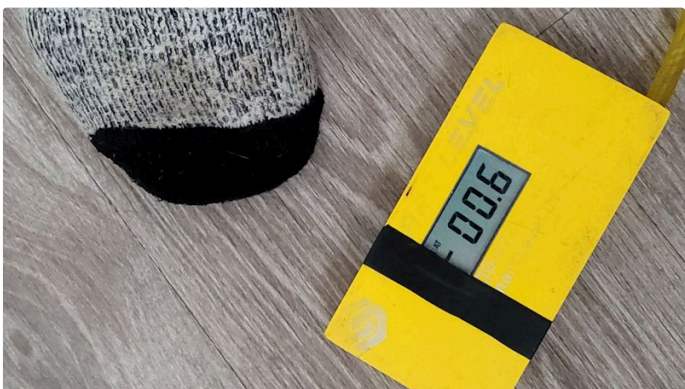
Ref #12.3 - Floor level reference photos

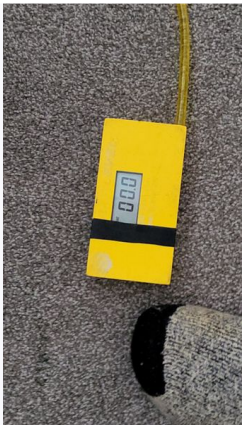
Ref #12.3 - Floor level reference photos

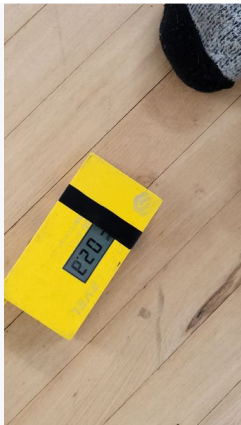
Ref #12.3 - Floor level reference photos

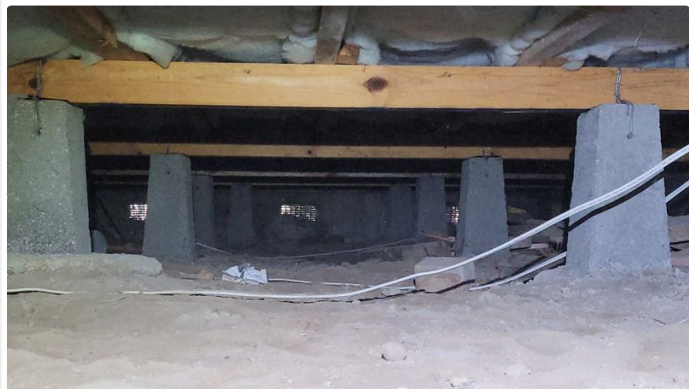
Ref #13 - Crawl Space example and reference photos;

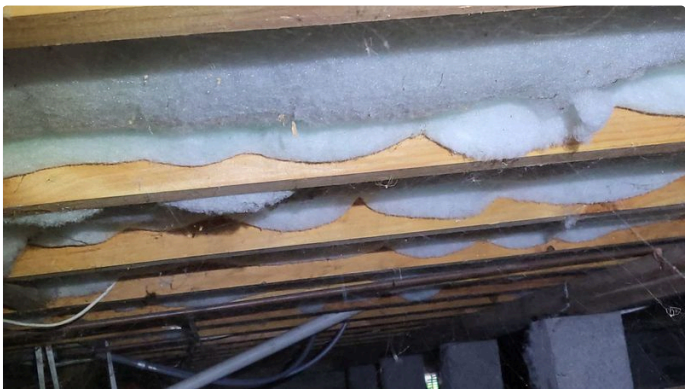
Ref #13 - Crawl Space example and reference photos; insulation example

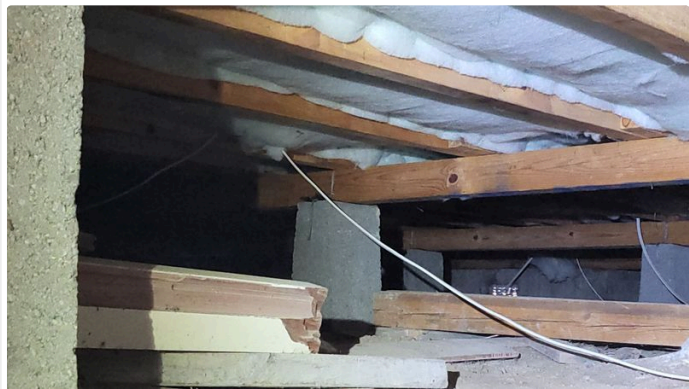
Ref #13 - Crawl Space example and reference photos;

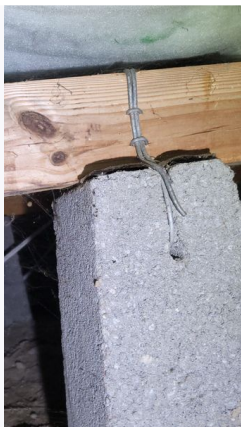
Ref #13 - Crawl Space example and reference photos; pile attachment method

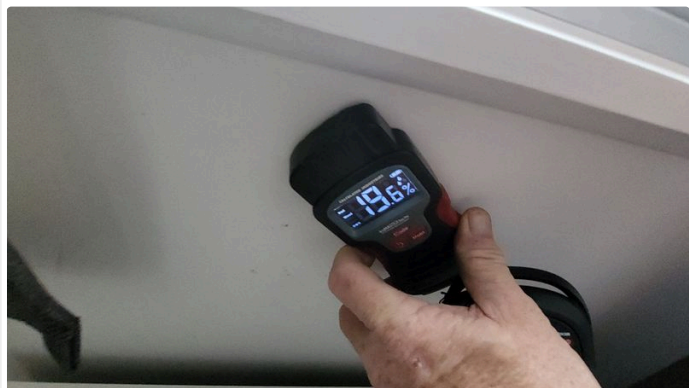
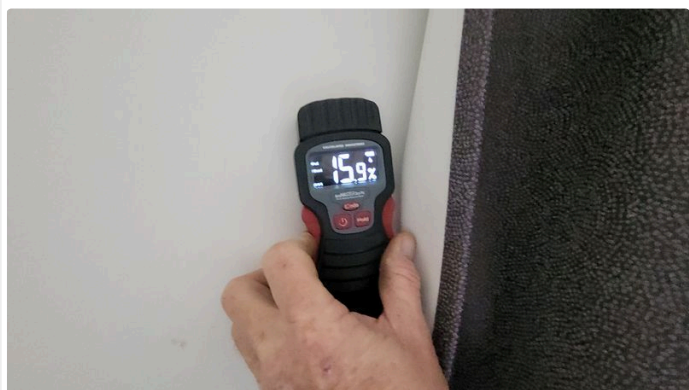
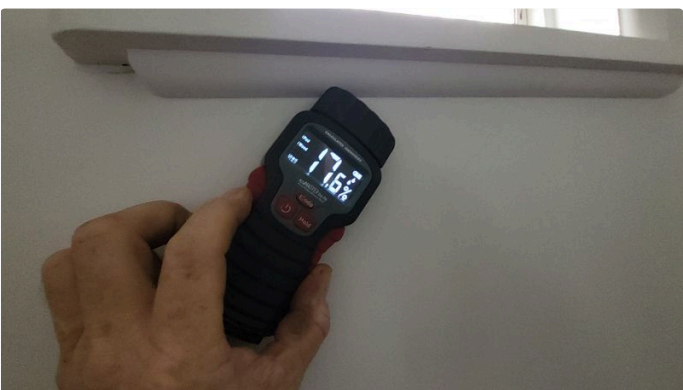
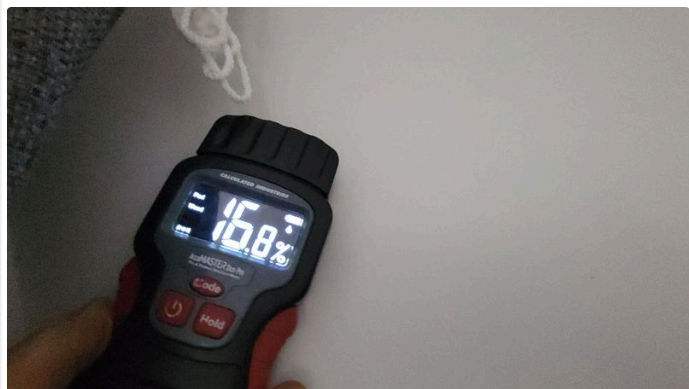
14.3	Windows	A representative number of windows have been checked and functioned satisfactorily at the time of the inspection
14.4	Moisture Readings	Moisture levels have been taken around indoor windows and other penetrations and key areas using a pinless moisture meter and Thermal imaging camera and all levels were satisfactory at the time of the inspection.

Ref #14.4 - Moisture Readings Reference example photos;

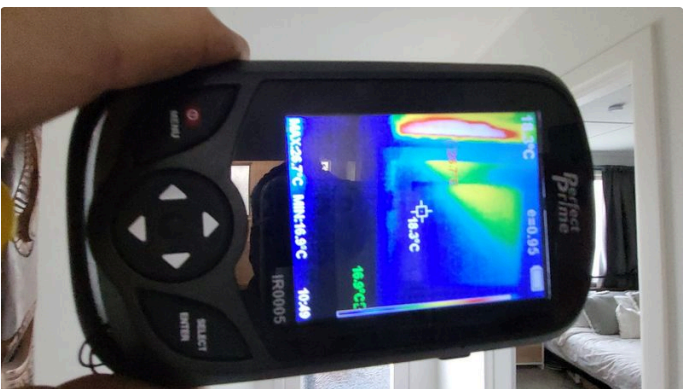
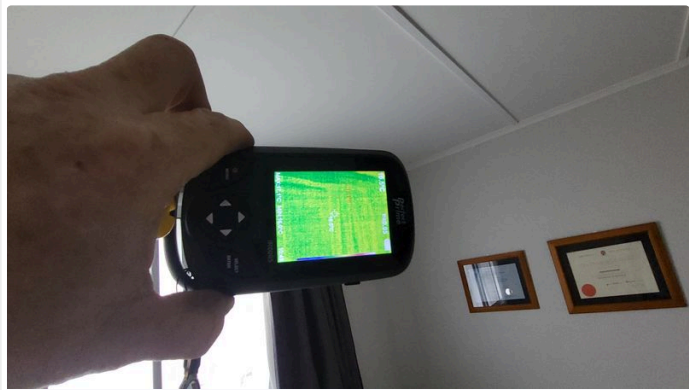
Ref #14.4 - Moisture Readings Thermal image Reference example photos;

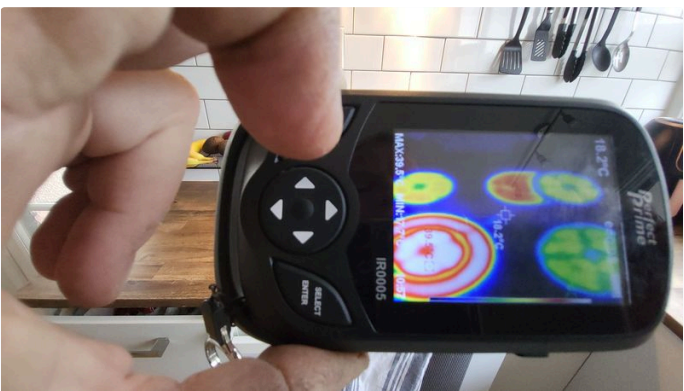
Ref #17.6 - Electric elements Observed Functioning at the time of the inspection;

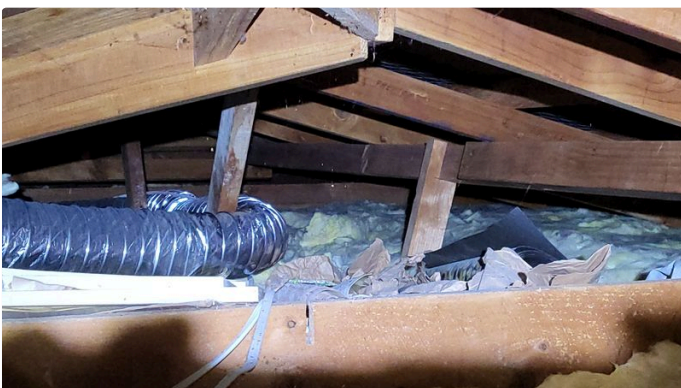
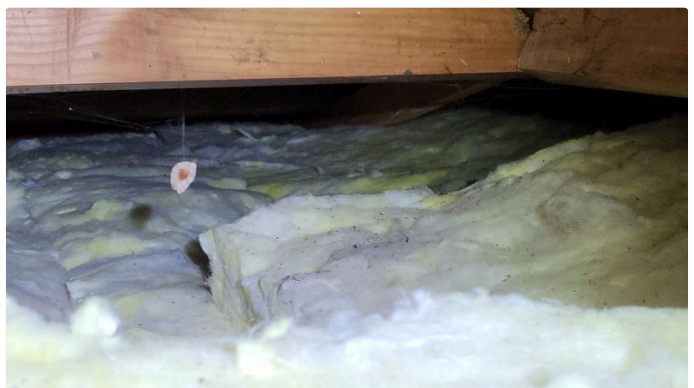
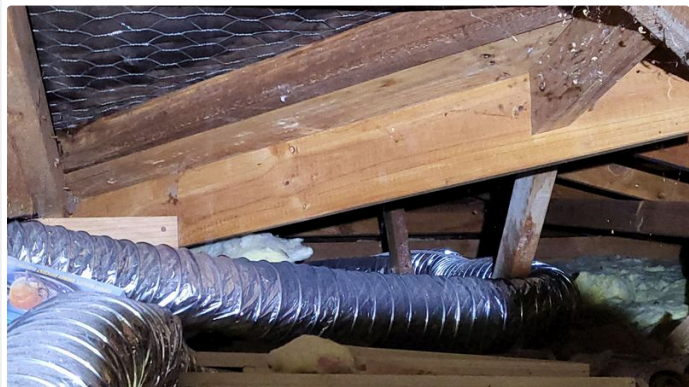
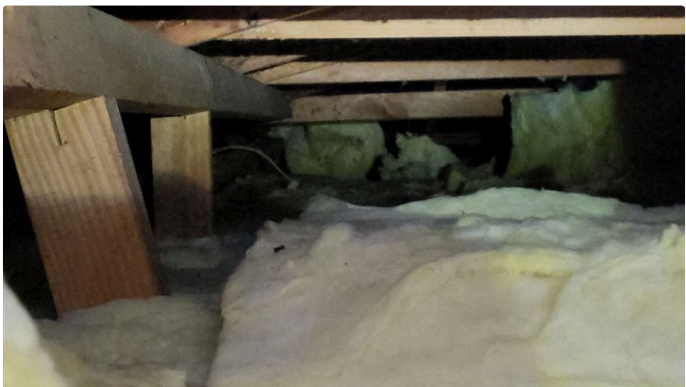
Ref #23 - Roof/ Ceiling construction and insulation example and reference photos;

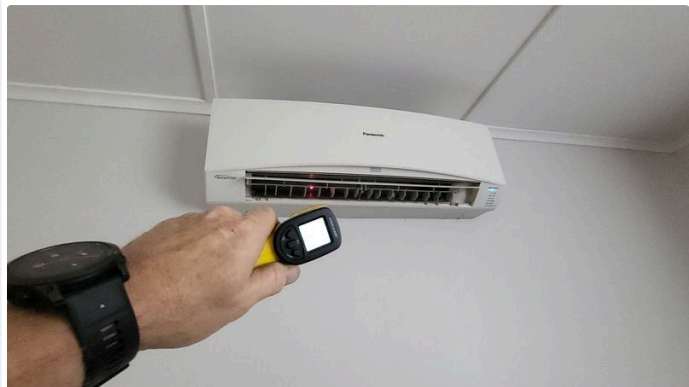
Ref #25.7 - The heat pump operated satisfactorily

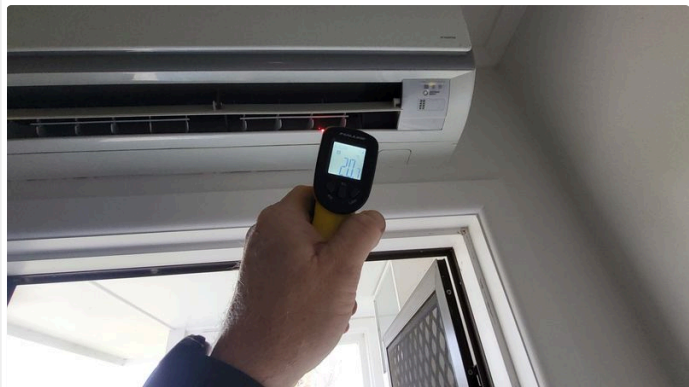
Ref #27.7 - The heat pump operated satisfactorily

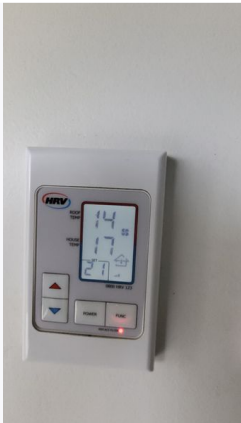
Ref #29 - Functioned satisfactory at the time of the inspection;

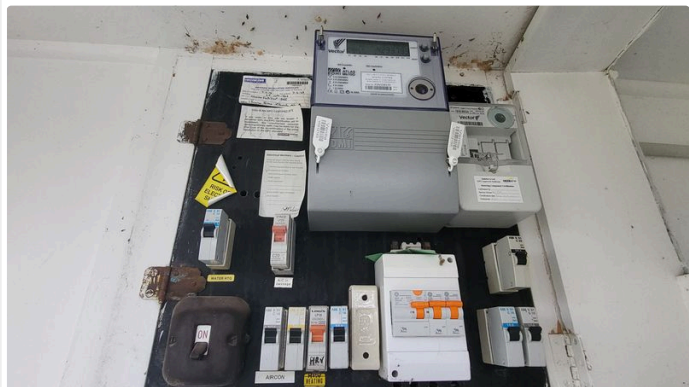
Ref #30 - Main board; mixed morden breakers installed

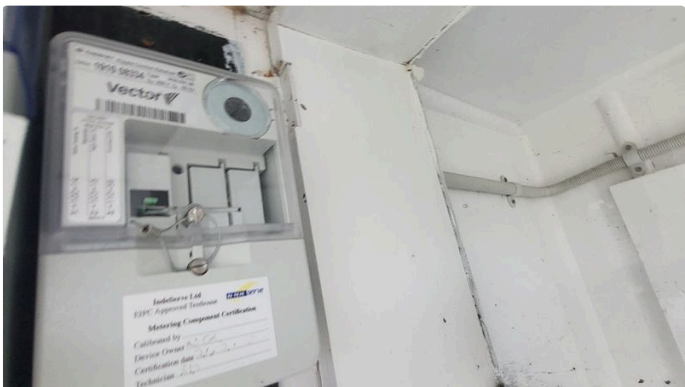
Ref #30 - Supplier switched Hot water installed

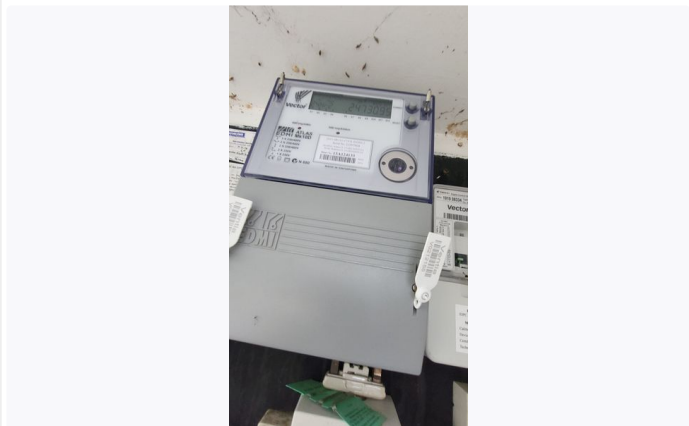
Ref #30 - Smart Meter

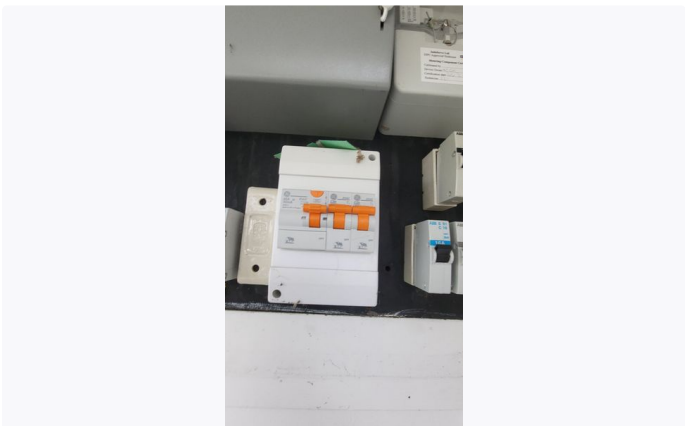
Ref #30 - modern RCD installed

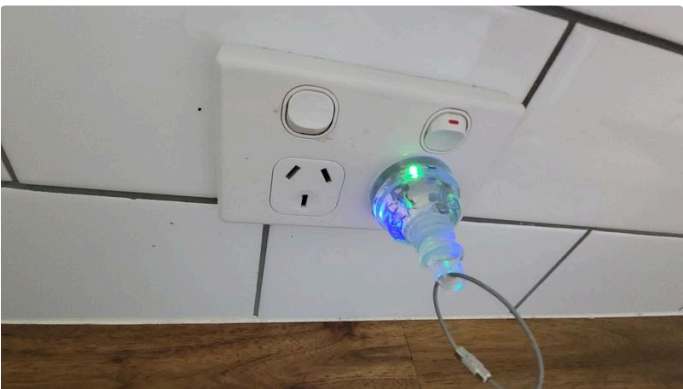
Ref #30 - Sockets polarity and earth have been checked

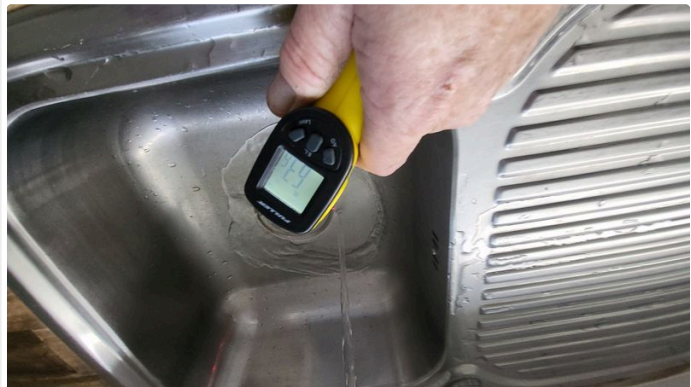
Ref #32.7 - The Hot water tested safe under 65 degrees at all outlets in the home
